# Mobile Crane Inspection Report

| <b>Job &amp; Report Number:</b> | J24430-SI02 | <b>Inspection Date:</b> | 22/07/2026 |
| <b>Client ID:</b> | LTC 1050-3.1 | <b>Capacity:</b> | 50T |
| <b>Vehicle Type:</b> | 2023 Liebherr LTM 1050-3.1 | <b>Registration:</b> | QCY398 |

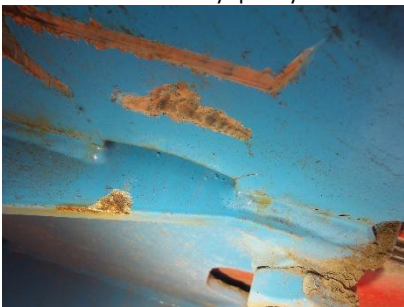
| 14 | Chassis & Super Structure | C | <b>Clean and tidy condition, minor damage under RHS rear.</b> |

| Actions | |
|---|---|
| <p>Item 14: Clean and tidy chassis with minor damage to secondary structure under the crane which is attached to Extension beam casing. Recommend that the damage be cleaned and repainted as it has stressed the welds to the casing and may cause rust to start very quickly.</p> | R |
