# Truck Mounted Crane Inspection Report

<b>Job &amp; Report Number:</b>	J21101-SI01	<b>Inspection Date:</b>	28/05/2025
<b>Client / Equipment Holder:</b>	Agtrans Ltd	<b>Contact Person:</b>	Phill / CJ
<b>Address:</b>	24 Fitzgerald Lane, Hawera.	<b>Contact Number:</b>	0800 AGTRANS / 027 278 6770
<b>Type:</b>	Truck Mounted Crane	<b>Boom Configuration:</b>	Knuckle Boom
<b>Official Number:</b>	ST.01250621	<b>Rating Sheet:</b>	Posted on crane
<b>Client ID:</b>	NQA 333	<b>Capacity:</b>	15,000kg (Max)
<b>Manufacturer:</b>	Palfinger – PK53002-SH F	<b>Hoist Rope Diameter:</b>	9.0mm (Not attached at time of inspection)
<b>SWL Indicator Type:</b>	Audio alarms & Cut-outs	<b>Hooks SWL:</b>	11.5 tonne
<b>Vehicle Type:</b>	2021 Mercedes Actros	<b>Registration:</b>	NQA 333

# Spreader Bar – Statement of Condition

<b>Job &amp; Report Number:</b>	J21101-S103	<b>Inspection Date:</b>	28/05/2025
<b>Client / Equipment Holder:</b>	Agtrans Ltd	<b>Contact Person:</b>	Phill / CJ
<b>Address:</b>	24 Fitzgerald Lane, Hawera	<b>Contact Number:</b>	0800 AGTRANS / 027 278 6770
<b>Type:</b>	Crane - Spreader Beam	<b>Boom Configuration:</b>	Extendable Beam
<b>Client ID:</b>	8000kg - NQA 333	<b>Capacity:</b>	8000kg S

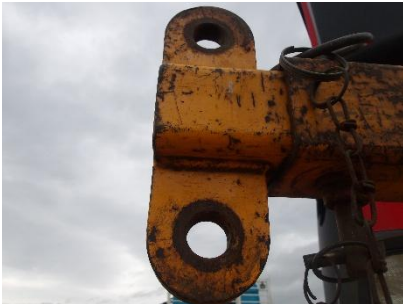
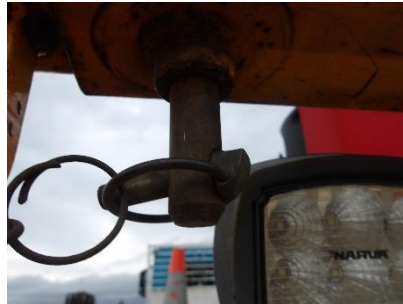
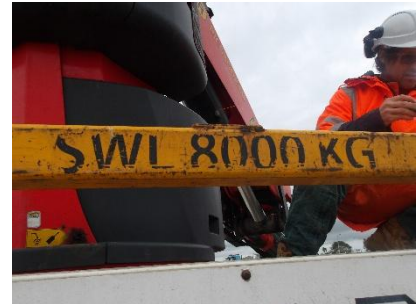
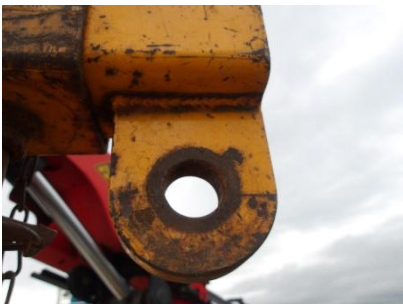
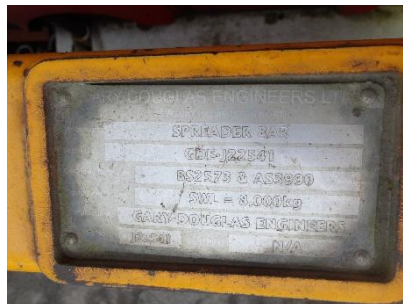
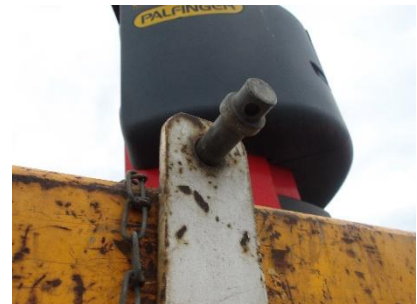
Additional Comments / Photos: Serial Number: GDE-J22541

Number	Check	Assessment	Comments
1	ID Number Visible	✓	Information on I.D plate. Satisfactory.
2	SWL Marked	C	<b>Weathered but visible, stencilled on beam.</b>
3	Main Structure – Body	✓	No noted damage, major rust or concerns.
4	Secondary Structure – Extensions	✓	No deformation or corrosion noted.
5	Lifting Points	C	<b>Minor wear noted around lifting lug holes, not concerning.</b>
6	Welds	✓	No concerns noted. Satisfactory.
7	Clips and pins - Extensions	✓	In place with locking clips to secure.
8	Paint Condition	C	<b>Few scuffs and chips, serviceable condition.</b>
9	Truck Attachments	✓	Pins secure with safety clips in place.
10	Bar mounts on truck.	✓	Sits in cradle welded to truck. Satisfactory.

Actions		Priority
Action		
Item 2- Re-label SWL		R
Item 2- Monitor wear at lifting lug holes.		R
Item 8- Perform paint maintenance.		R
Priority:	M Mandatory by certificate expiry	R Recommendation
